Docket No. 217 – Development and Management Plan Inspection

Northeast Utilities Service Company Certificate of Environmental Compatibility and Public Need for the construction of a 345-kV electric transmission line and reconstruction of an existing 115-kV electric transmission line between Connecticut Light and Power Company's Plumtree Substation in Bethel, through the towns of Redding, Weston, and Wilton, and to the Norwalk Substation in Norwalk, Connecticut.

Date: October 13, 2006

Location: 345kV XLPE Component

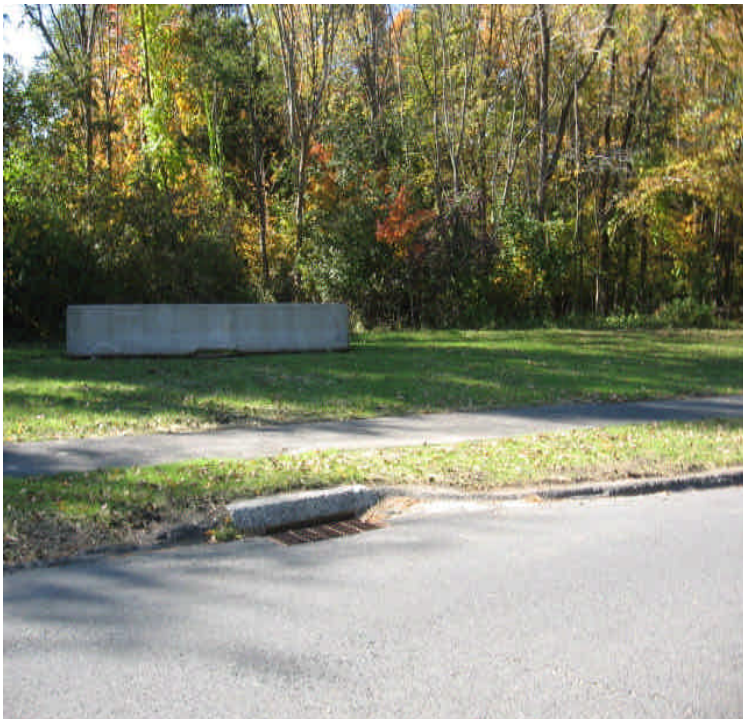
Photo on the left shows grass growth in recently restored vault access areas along Whittlesey Drive. Photo on the right shows the jacking pit side at the jack & bore following restoration. Grass cover is establishing well and the erosion control matting remains in good shape. 10/13/06

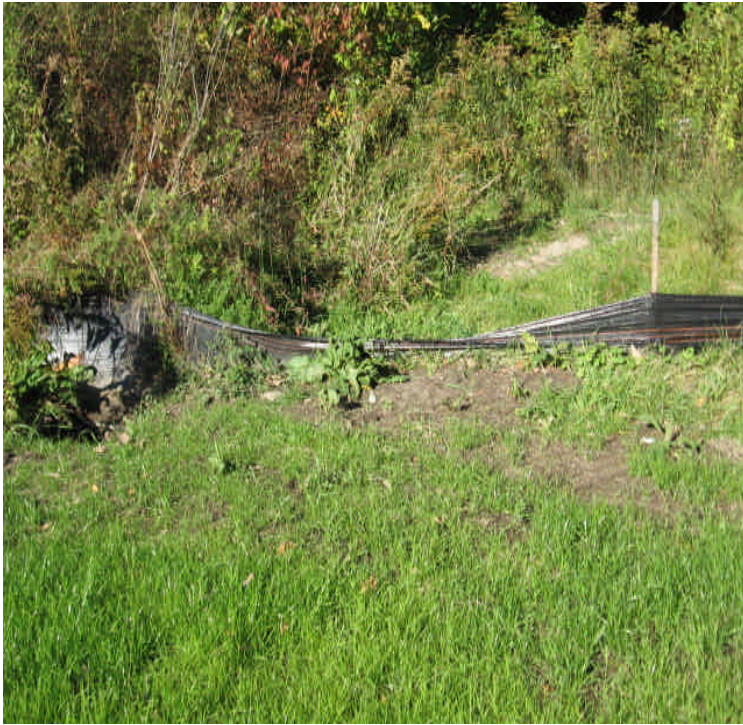
Photo on the left shows a section of silt fence at the jack and bore which may need to be replaced with haybales as a precautionary measure. The silt fence can be removed completely. Photo on the right shows the restored area in the ballpark. This area has stabilized with vegetation and silt fence can be removed. 10/13/06.

Erosion and Sediment Controls (includes inspection within 24	<p>- The jack & bore area is stable with well established grass cover. The erosion control</p>	<p>-Silt fence could be removed completely here but a few haybales should be added in strategic</p>	<p>-The area appears stable.</p>

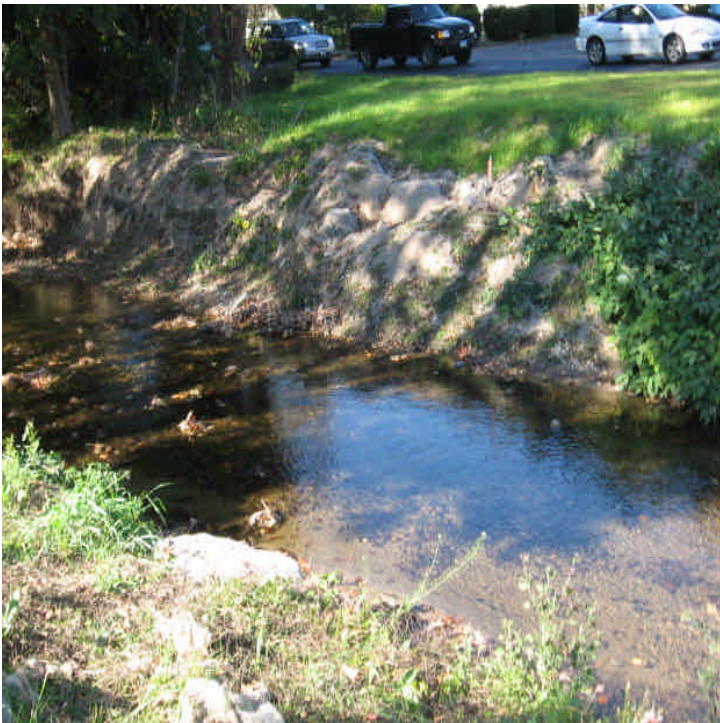
Inland Wetland and Watercourse encroachment and mitigation	-The banks of East Swamp Brook remain in good shape but additional stabilization measures may be necessary. Vegetation is sparse here. 9/7-10/13/06	-Continue to monitor until and consider additional stabilization measures. 9/7-10/13/06	May need attention prior to the end of the growing season
State species of concern, threatened and endangered species	<p>-The D&M plan and clearance letter states that state-listed species are not located in this work area however,</p> <p>-The wood turtle was noted at Plumtree</p>	<p>- N/A</p> <p>-345kV XLPE crews should also be performing daily walkthroughs before moving equipment if</p>	<p>-N/A</p> <p>- N/A</p>

Photo on the left shows the stream bank with patchy vegetation returning. Additional seed or alternative stabilization measures may be needed here. Photo on the right shows that grass growth has increased significantly in the vault 2 area. 10/13/06
